SPICA Fuel Injection Roadside Fault Analysis and Repair

This guide is intended to aid the owner-mechanic in understanding and diagnosing Alfa Romeo SPICA injection pump malfunctions. It is not a substitute for the official factory technical publications. No claim to absolute accuracy or utility is expressed or implied. The reader uses this guide at his own risk.

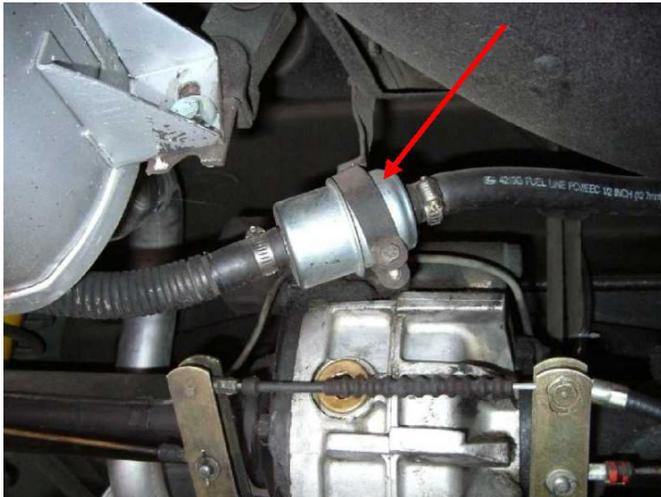
Fig 1. Rear Fuel Filter

1. **Clogged fuel filter.** Change the rear filter with the spare you always keep in the trunk. A clogged fuel filter probably will be slowly progressive, so you should be able to limp-in somewhere. See Fig. 1.

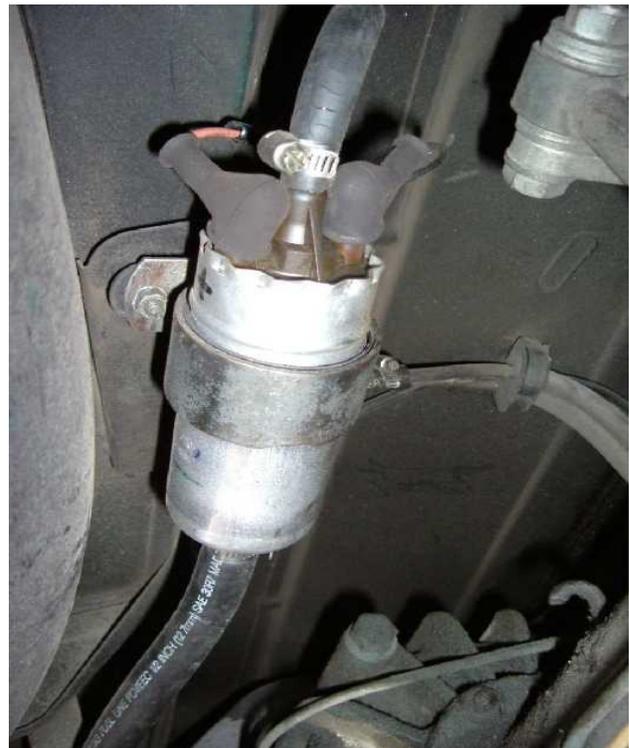
Fig 2. Fuel Supply Pump. Pictured pump is a Bosch L-Jet type. You may have the older model with 3 ports on one end, or two ports in an "L" shape, or even an original AEG pump.

failing. *If the reason is overheated fuel (causing vapor lock/cavitation) this will only make it WORSE.* Adding cool fuel may temporarily help a failing pump to put out more pressure. See Fig 2.

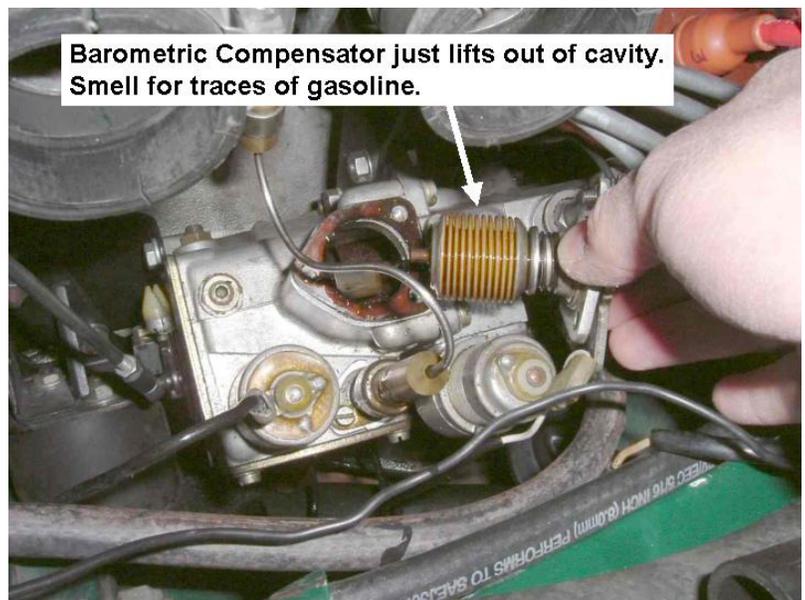
Fig 3. Removing the Barometric Compensator. To remove the BC simply remove the three machine screws and lift the BC out. It's not attached to anything inside.

VERIFICATION: Remove the Barometric Compensator and look for a broken retaining spring. See Fig. 3. You can use your finger to push on the spring to verify that it's attached at the top and bottom. See Fig. 4.

- a. Remove Barometric Compensator (3 screws) See Fig. 3.

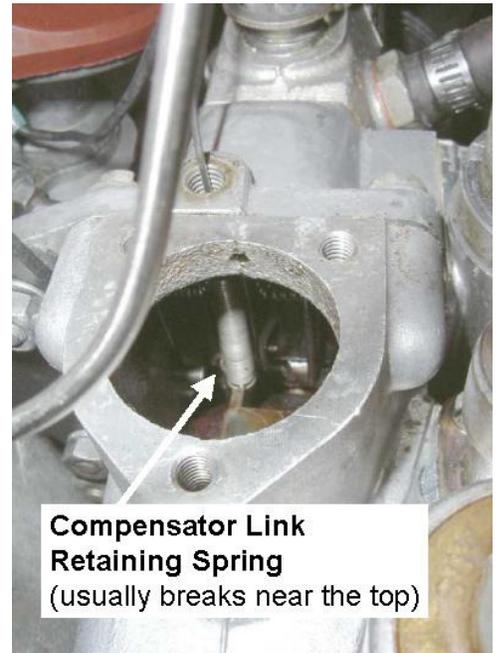
Fig 4. Compensator Link Retaining Spring.

b. Grab upper end of spring with forceps. See Figs. 4 through 8. Pull upper end up to meet the retaining screw that goes through the top of the pump body. Position the screw so it's just through the casting, then hold the spring up against the screw gently and turn the screw to thread it on. It may help to reposition the link arm at the upper limit of the vertical notched lever. This will allow you not to have to put so much upward tension on the spring while reattaching it. When done, reposition the compensator link to about middle (7th notch down). To reposition the compensator link, push rearward at the place indicated in Fig. 7., lift/lower the link then allow it to go forward again. Use caution when doing this with T237/1 ('69 model) pumps. Those pumps do not have an upper stop to prevent the compensator link arm from coming off the vertical notched lever. When done, reposition the link arm to about the middle position. This will allow the engine to start and run. Accelerate the engine to 3000-4000 rpm then closing the throttle will automatically reset the compensator link to the correct position.

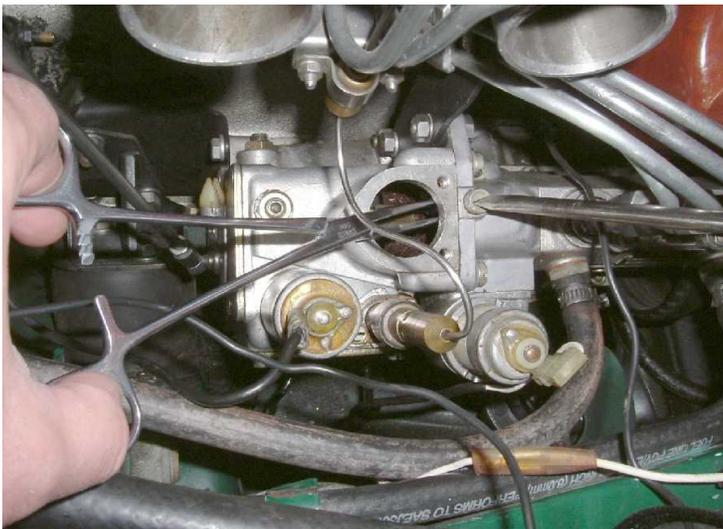
Fig 5. Reattaching Retaining Spring to upper machine screw.

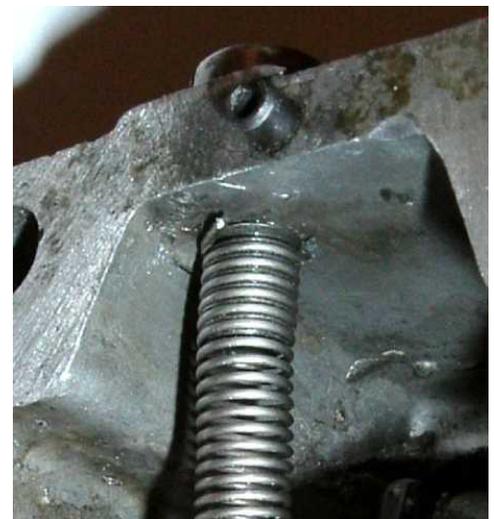
Fig 6. Retaining Spring upper attachment point

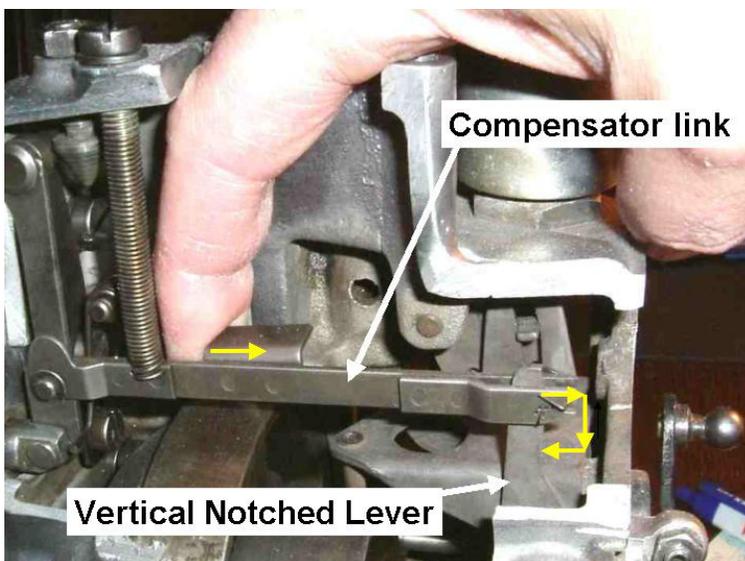
Fig 7. Resetting Compensator Link. Push rearwards to disengage from notched lever, move up or down, then let it come back forward to engage the notched lever again. Cutaway shown is a '69 model pump. Newer pumps have an upper stop to prevent the compensator link from coming off-track.

d. If the compensator link has fallen to the bottom of its range, you should reset it to about the middle of the range. Do this by putting your finger on the compensator link from the Barometric Compensator cavity and push rearwards on the link. You can then move the link up and down and reset it on a midrange notch. See Fig 7.

You can remove the Barometric Compensator and manually reset the compensator link to a nominal position (7th notch from top) See Fig 7. You may then drive with very slow throttle movements, being especially careful NOT to fully close the throttle from higher engine rpms. Fully closing the throttle from high rpms allows the compensator link to disengage the vertical notched lever (to reset itself). With a broken compensator link retaining spring, the compensator link arm will fall to the bottom of the range, leaning the mixture to the point of stalling the engine.

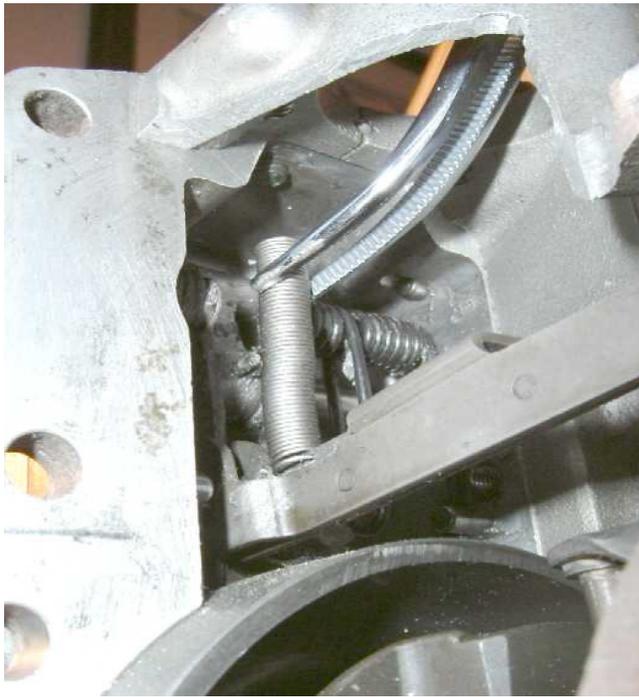
Fig 8. Inside cutaway view of forceps grasping retaining spring. Note upper attachment point (machine screw) just poking through the casting.

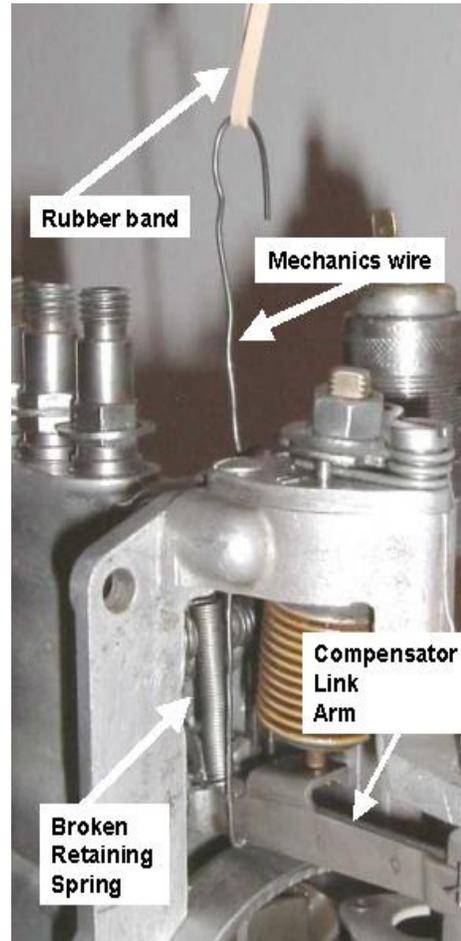
Fig 9. Cutaway view of Method 2 temporary repair.

b. Next insert a piece of wire or paperclip through the screw hole and make a hook in the end, after you pass it through the hole. Hook it around the bottom of the compensator link as shown. (See Fig 9)

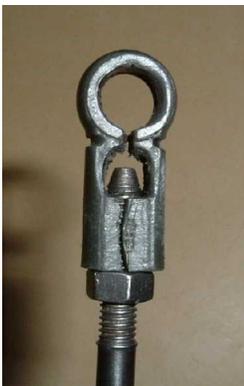
Fig 10. Cracked Rod End

POSSIBLE CAUSE: Cracked or completely broken rod end (plastic piece on end of long or short rod) resulting in a change of length of the rod. See Fig. 10.

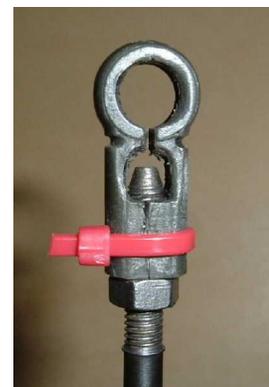
Fig 11. Cracked Rod End temporary repair with plastic wire tie.

EMERGENCY FIX: The locking nut for the plastic end piece is probably still in the correct position. Move the end piece to the correct position and secure it in place with the plastic wire tie. See Fig 11. With the short rod the correct position will be with the throttle in the idle position and the throttle butterflies “just” closed in their bores. The correct long rod position will be so the throttle arm on the rear of the injection pump is sitting in its hot-run position (very close to the reference screw)

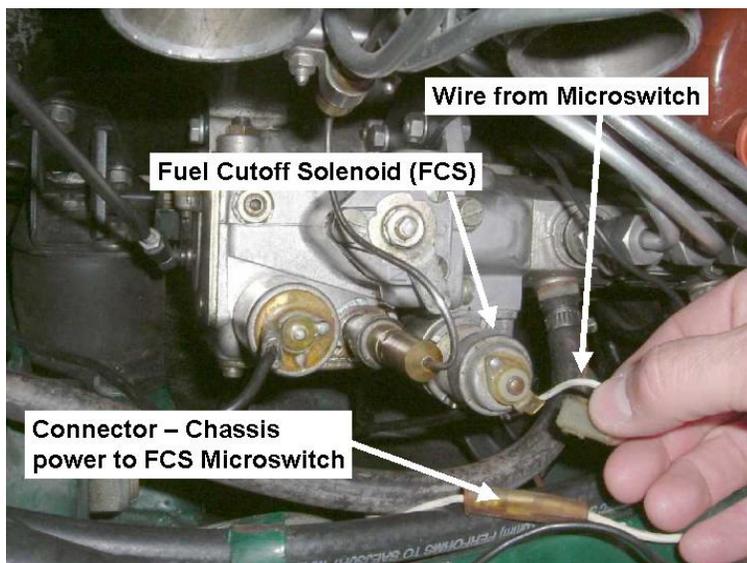
Fig 12. Fuel Cutoff circuit showing wires from chassis to Microswitch to Fuel Cutoff Solenoid (FCS). FCS circuit energized via fuse #6.

2. See Figs 12 and 13. Disconnect the wire from the spade terminal of the FCS (forward-most actuator on the mid-top of the injection pump). Tape and secure the wire end so it won't short out against anything. This wire can be reached without removing the airbox.

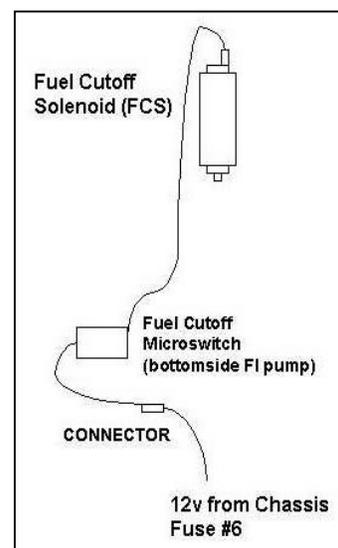
Fig 13. FCS wiring detail.

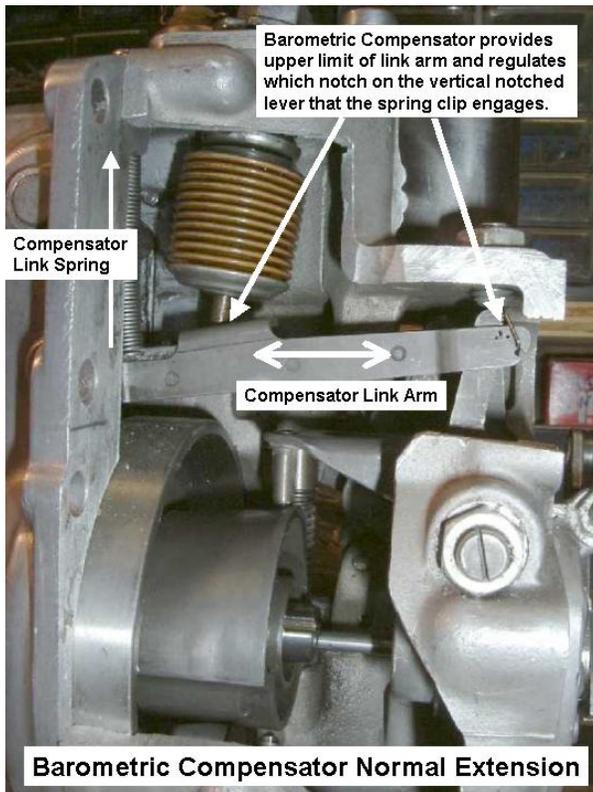
Fig 14. Barometric Compensator Normal Extension

Failed Barometric Compensator. This is very uncommon. The Barometric Compensator is a sealed bellows unit that expands or contracts with absolute atmospheric pressure, thus enriching or leaning the mixture for optimum performance. If this bellows loses its seal, there is a spring inside that will expand the bellows from a normal approximately 27mm to about 40mm. See Figs 14 & 15. The appearance change will be very obvious. The unit will look very extended. When this happens the greatly expanded Barometric Compensator will reset the compensator arm link very far down and greatly lean the mixture (like the engine was trying to operate at a VERY high altitude). It will likely lean the mixture to the point of stopping the engine.

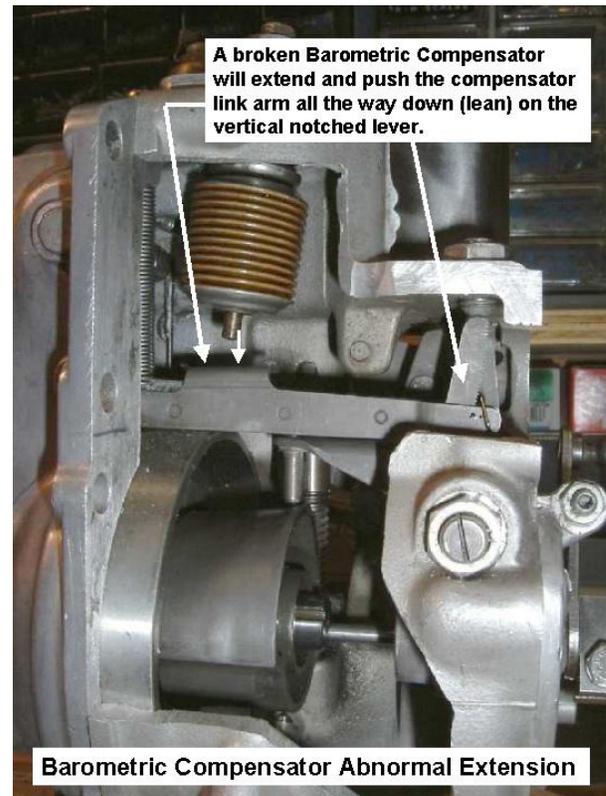
Fig 15. Barometric Compensator Abnormal Extension (simulated). An actual failed BC will greatly extend and reposition the Compensator Link Arm full down (fully lean).

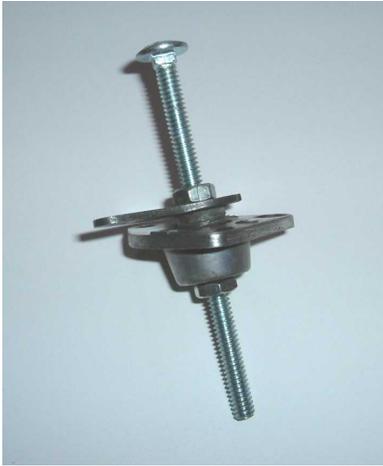
Fig 16. Substitute BC made from 1/4" bolt and 2 nuts

EMERGENCY FIX: Remove the Barometric Compensator from the top of the injection pump (3 screws). Carefully lift out the bellows assembly (it's not attached to anything inside the pump). If it's obvious that the bellows has failed, remove the bellows unit from its mounting plate and substitute a 1/4" x 3" min. length bolt in the top plate's hole. See Fig 16. The bolt should be 27mm long from the bottom of the plate to the end of the bolt. If possible, the bolt's end should be rounded and smoothed as much as practical, since it will slide along the surface of the compensator link arm.

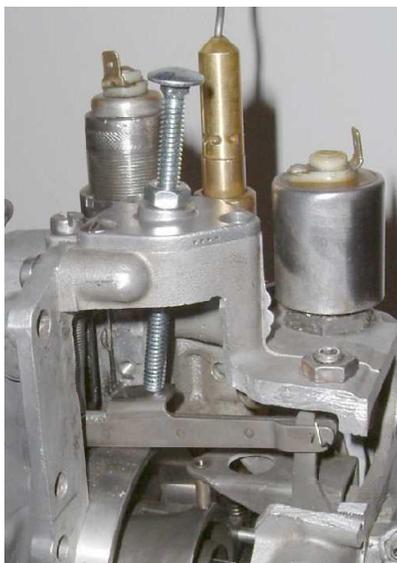
Fig 17. Dummy BC installed in cutaway of logic section. It is essentially a "fixed" BC now and will not adjust the pump mixture for changes in altitude and air density. Adjusting the length so as to engage the 7th notch of the vertical notched lever. (nominally 27 mm), will put it close enough for the engine to run.

Remove the BC from its mounting plate and substitute a ¼" bolt. See Figs 17 and 18. Set the length of the bolt beneath the mounting plate to just touch the compensator link arm when positioned at the 7th notch on the vertical notched lever.

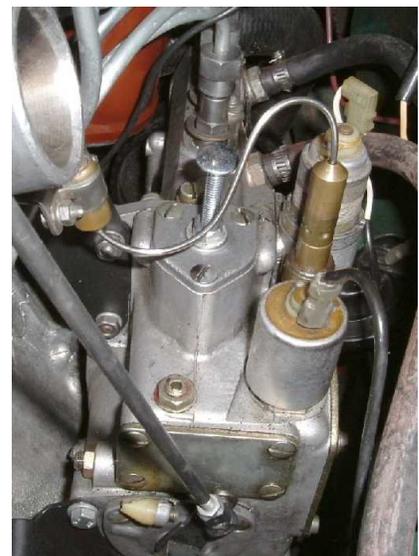
Fig 18. Dummy BC installed in car's injection pump.

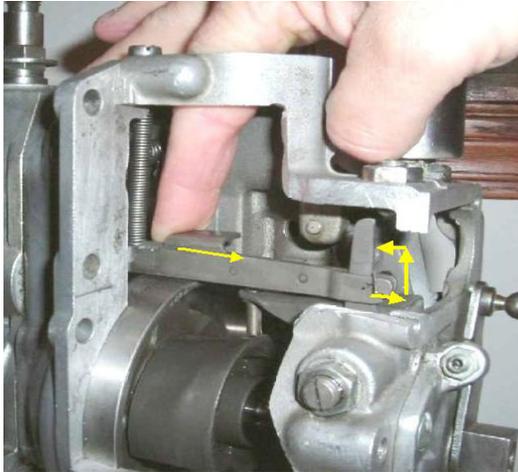
Fig 19. Cutaway view of Resetting the Compensator Link on the Vertical Notched Lever. In the event of a broken Compensator Link Retaining Spring or a hyper-extended Barometric Compensator bellows, the Compensator Link will probably drop to the bottom of the vertical notched lever (full lean), as demonstrated in this photo. To reset the compensator link arm to a useable setting on the vertical notched lever, simply remove the Barometric Compensator, reach in with your finger and pull slightly back, then up, then let the link back forward to engage a notch slightly higher than the middle position. The engine must be warm or a dummy TA fitted to ensure that the throttle arm is close to the reference screw (pump gap). When the engine is cold, the TA moves the vertical notched lever rearwards and makes it very hard to manually move the link rearwards enough to disengage the notched lever. Drive using very slow throttle movement. The goal is not to put the 3D cam in the high rpm, closed throttle regime. That's when the Compensator Link is released from the Vertical Notched Lever and allowed to reset itself according to the upward stop provided by the Barometric Compensator

Remove the BC and reset the compensator manually to about the 7th notch on the vertical notched lever. This can be done by removing the rear inspection plate and looking with a mirror. Much easier is to reach down thru the BC cavity, pull the compensator link to the rear, then raise it to full up and release. See Fig. 7. Next push directly down on the link and count 4 clicks. Since the full up position is about at the #3 notch, 4 clicks down will be the 7th notch. Remember, this is an emergency limp-in measure. To prevent wear on the vertical notched lever and the hairspring clip, you don't want to do this any more than necessary. See Fig. 19.

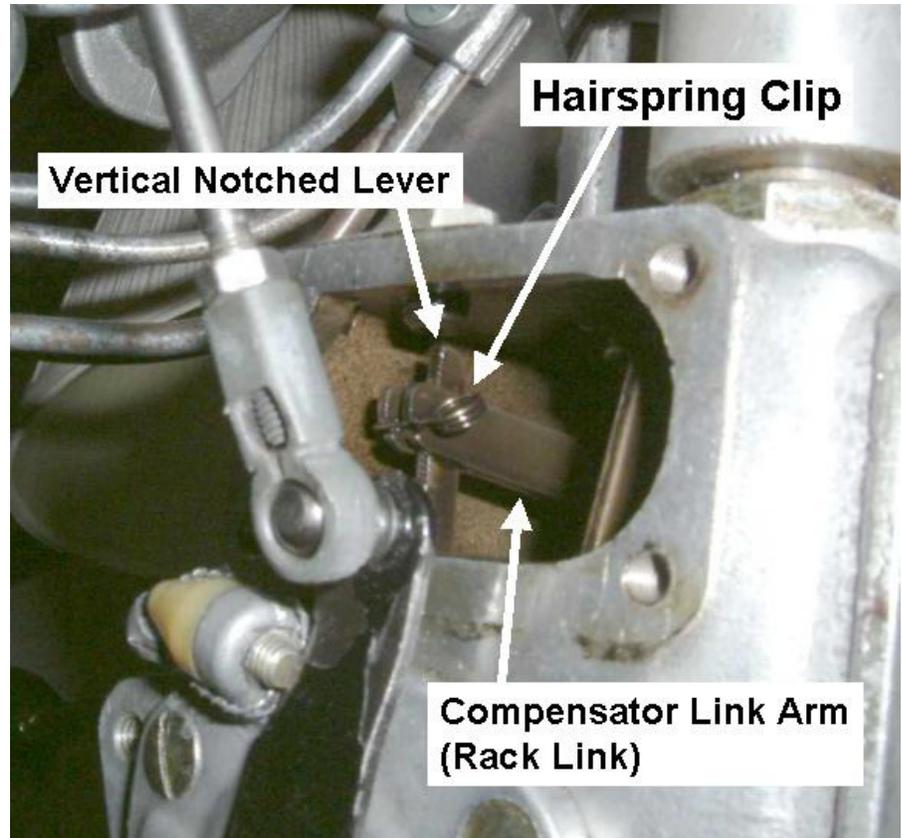
Fig 20. Hairspring Clip as seen through the rear inspection port of the FI pump. If it breaks, the Compensator Link Arm (AKA Rack Link) will go full forward (lean fuel cutoff) and the engine will stop. No throttle control is possible since all driver throttle inputs are translated through the Vertical Notched Lever. There are three possible holes to place the Hairspring Clip. It should go into the middle hole. Diameter of the Hairspring Clip is .023", so any emergency substitute must be that or slightly smaller.

Broken hairspring clip on end of rack link. See Fig. 20. This hairspring clip engages the Barometric Compensator in the correct notch on the vertical notched lever. The Vertical Notched Lever is the link that transfers the driver's throttle commands to the pump section. If this hairspring clip breaks or comes off, the compensator link will go full forward to the fuel cutoff position. Access to the hairspring clip is through the inspection plate on the rear of the pump.

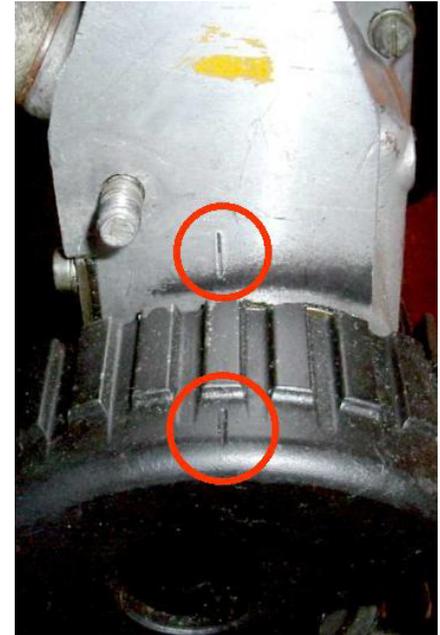
Fig 21. Injection Pump Timing Marks

1. Remove fan belt.
2. Time injection pump to engine. First, set the engine to "P" (TDC) at the beginning of the #4 (NUMBER FOUR) cylinder power stroke, then rotate the engine CCW (as you're looking towards the rear of the car from the front) to the "I" mark (70 deg BTDC). Next line up the index marks on the front of the injection pump body and pulley as shown in Fig. 21. Install the new belt on the crankshaft pulley first. The belt will slip through the small slit between the crankshaft and the front cover. Then, without changing the position of the crankshaft or injection pump pulley, slip the new timing belt onto the injection pump pulley. Do not use levers or sharp objects. Using some WD-40 is ok.

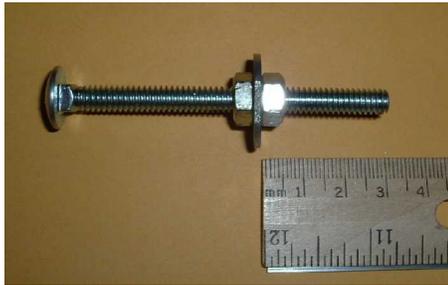
Fig 22. Emergency Substitute TA consisting of 1/4" x 3" stove bolt, two nuts, and washer. Nuts adjusted to give correct length.

Fabrication of Emergency Substitute T/A: A makeshift T/A is easily made from commonly available materials. A 1/4" x 2" or longer machine screw or bolt, two nuts, and a washer is all that is needed to fabricate a makeshift substitute T/A. Anything that will push down on the adjustment mechanism by 27/29mm and be held in by at least one of the T/A hold-down screws will suffice.

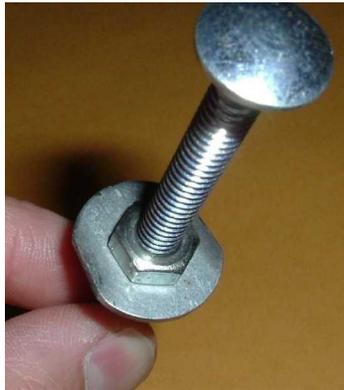
Fig 23. Emergency Substitute T/A
Note filed off edges on washer in order to fit width of existing machine screws

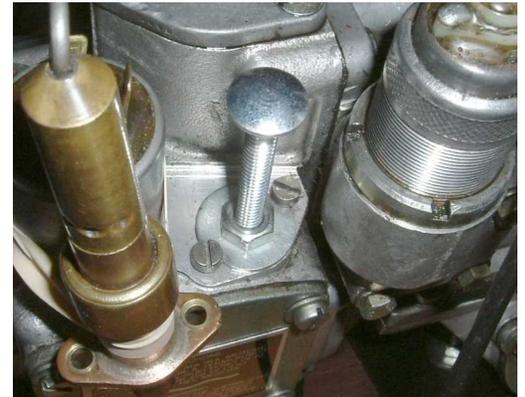
Fig 24. Emergency Substitute T/A installed. Note inoperative TA secured to prevent damage to TA pipe.

Remove the center T/A support and the lower part of the T/A from the injection pump. Do not remove the upper part that fits in the coolant jacket on the intake manifold. Securely tape, wire, or strap the lower part of the TA to the injection pump to prevent the thin tube from being stressed by engine vibration. You want to prevent breaking the TA's tubing. Next, insert a dummy TA set to the correct length for your pump's year.

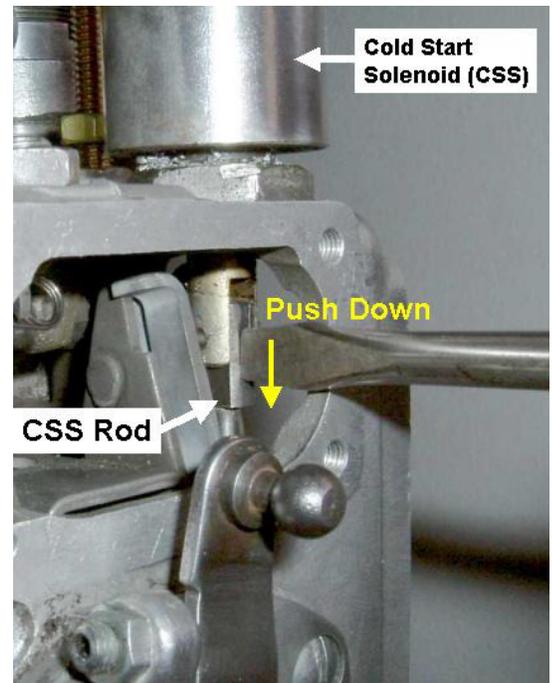
Fig 25. Freeing Stuck Cold Start Solenoid. Remove rear inspection plate, then push down on CSS Rod as pictured. CSS Rod only moves about a 1/4".

If the problem is a sticky CSS, you may be able to free it with a light rap from a plastic hammer on the rear of the logic section. If that doesn't work, and the CSS is really stuck, you may be able to free it by removing the inspection cover on the rear of the pump, taking a screwdriver and pushing down on the rod that the CSS connects to. Some spray lubricant, such as WD-40 may help also if the pump logic section has not been maintained adequately. After freeing the stuck CSS, leave the CSS wire disconnected and wrapped to prevent a short. The CSS is not absolutely essential to starting the engine, and leaving it disconnected will not damage the FI pump. If starting is difficult, spray a little starting fluid (ether) into the opened airbox. That will help the engine to initially fire.
