SPICA FUEL SUPPLY SYSTEM DIAGNOSTIC GUIDE

By John Stewart

This guide is intended to aid the owner-mechanic in understanding and diagnosing Alfa Romeo SPICA fuel supply system malfunctions. It is not a substitute for the official factory repair publications. No claim to absolute accuracy or utility is expressed or implied. The reader uses this guide at his own risk.

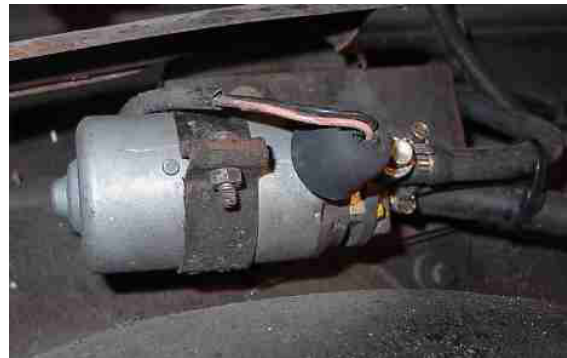
'69-'74 2-port Pump Installation (right axle area).
Fig 1

The fuel supply system for the SPICA (say "speak-ah") injection system is a medium pressure (10-20 psi) closed loop recirculating system. See Appendix 8 for schematics of the fuel system. On '69 thru '74 models, fuel gravity exits the fuel tank, goes through a in-line filter, then to the fuel supply pump where it is put under 10-20 (ideally 15-18) psi and pumped forward to the canister type main fuel filter on the right side of the engine compartment. The canister has several functions. It filters the fuel again, has an inline pressure-sending unit that detects pressure below 7 psi, and may have a pressure relief valve ('69-'74). The pressure regulator is inside the big cap screw that secures the brass fitting that the fuel return line passes through. If the pressure is above 17 psi, the relief valve opens and vents fuel back into the fuel return line to the tank. If below 7 psi, the top left red light on the center instrument panel illuminates. After the front fuel filter canister, the fuel enters the SPICA Injection Pump through the rear fuel inlet fitting where it is used for engine and cooling/lubrication purposes. Unused fuel exits the pump through the front fuel outlet fitting. This fitting has a restrictor orifice (3/32") that allows the supply pump to maintain adequate pressure in the injection pump fuel galleries. If, for some reason, you remove both fuel fittings and inadvertently reverse them (putting the restrictor in the rear), you will have "apparent" good pressure (fuel low pressure warning light OUT), but have very little pressure in the injection pump fuel galleries and the engine will probably not run well, if at all. After passing through the restrictor, the fuel passes through the segregated top section of the main fuel filter (containing the PRV) and then back to the fuel tank.

A healthy pump will emit a medium frequency audible "hum" into the passenger compartment and produce about 10 psi under battery-only power, and about 15 psi with the alternator running and a charging voltage of 13-14V. As you can see, the fuel supply pump is very sensitive to voltage and current. Lower than 12V seriously degrades the pump speed and pressure. Wiring with high resistance, a weak battery, or a failing alternator will have a direct affect on the efficiency of the supply pump.

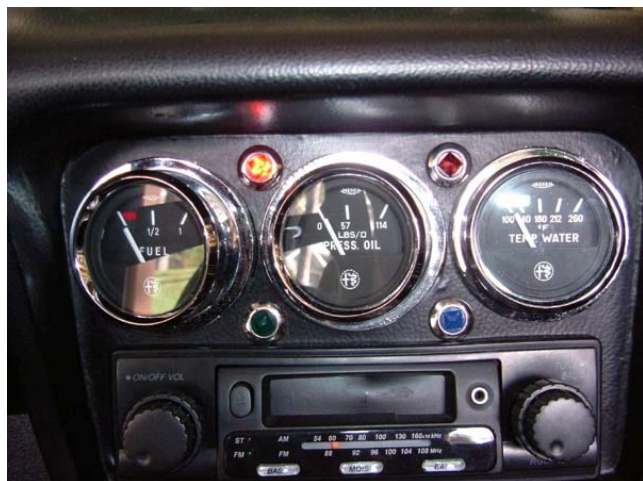
**Spider Center Instrument Panel.
Note Fuel Low Pressure Warning Light Illuminated.
Fig 4**

Fuel pressure is monitored by the driver via the upper left red warning light on the center instrument panel. See Fig 4. The light illuminates when the pressure in the fuel feed line is below 7 psi. In normal day-to-day operation you should never see that light illuminate except just prior to starting the engine. When first turning the key switch to ignition, it takes a few seconds for the fuel supply pump to build pressure in the line. If the light takes more than a few seconds to extinguish, there is likely a problem developing in the system, such as a clogged filter, discharged battery, or a failing supply pump. In Fig 4 also note that the fuel level in the tank is very low with an additional low fuel level red indicator illuminated. Do not run very low fuel levels in the fuel tank. Fuel is used to cool the injection pump. On a hot day, low fuel tank levels in the tank can soak up considerable heat from the pavement and engine and in extreme circumstances hot fuel could cause fuel supply pump cavitation.

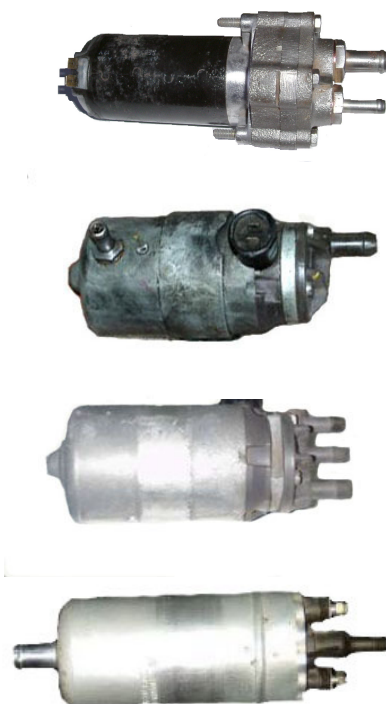
**Fuel Supply Pump Models
Figure 5**

Original SPICA/Bosch, 2 Port Models

Original Bosch, 3 Port Model ('75-'79)

Bosch L-Jetronic ('80-'81 SPICA, '82+ L-Jetronic
(PRV = Pressure Relief Valve)

Caution: Do not pressure test these pumps via "deadhead" method. They can put out extreme pressures when deadheaded and could cause rubber fuel line rupture and possible fire.

The main supply pumps were primarily manufactured by Bosch, but also SPICA and AEG (very rare). The old AEG pumps were dry motors with a separate geared pump section. Bosch and SPICA pumps operate "wet," meaning that the entire interior including the electric motor section of the pump is bathed in fuel. Since there is no air in the pump, there is no danger of igniting the fuel. Although you can sometimes find rebuilt original supply pumps, the later Bosch supply pumps from the L-Jetronic systems and the Pierburg pumps work fine and are a good and readily available substitute. They are also new, as opposed to the rebuilt replacements. If you are replacing a 3-port pump, you will have to make minor modifications, by capping off the supply pump return line or removing it altogether (leave the main return line alone). The older pumps originally equipping SPICA injected Alfas look different from the L-Jetronic models. See figure 5.

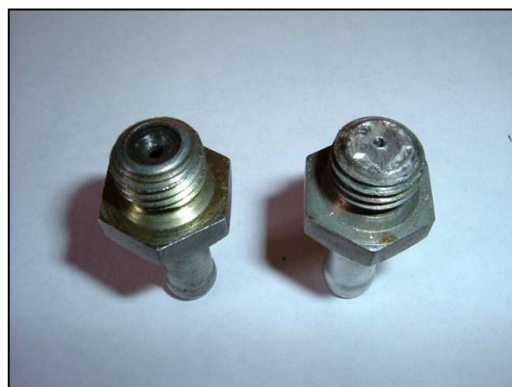
Fig 8

Outlet Restrictors. Left one is stock (3/32"). Right one has been soldered-in and redrilled with a 1/16" drill.

SPICA or old-style Bosch supply pumps, which put out a large volume. When substituting the slightly lower volume L-Jetronic supply pump, the restrictor should be made smaller to maintain 15-18psi in the system. If the restrictor is left at 3/32," it's likely that the low-pressure warning light will be on (< 7psi) with just battery power, and only maintains 10psi or so with the alternator running. Optimum is 15-18 psi. See Fig. 7. To modify the restrictor, remove the fitting from the pump and fill it with electrical solder and re-drill with a 1/16" drill bit. A simple propane torch works well to melt the solder into the existing hole. See Fig. 8.

The restrictor in the FI pump outlet fitting was normally 3/32" in diameter, although depending on the year, it may be different. This size restrictor was meant to work with the
